## Engineering Failure Analysis - A Review

- Mr. Abraham Pannikottu  
Operations Manager

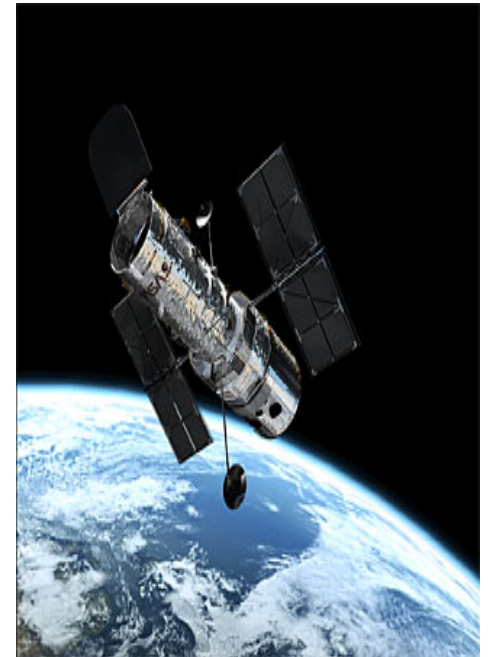
## Hubble Space Telescope

- **Background**
  - Designed in the 1970's and launched 1990
  - The first major orbiting space based observatory
- **Problem**
  - The curve to which the primary mirror was ground was incorrect, causing "spherical aberration"
  - The flaw resulted in a fuzzy focus image
- **Impact**
  - 4 costly servicing missions in 1993-2002
  - More than \$3 billion spent to date

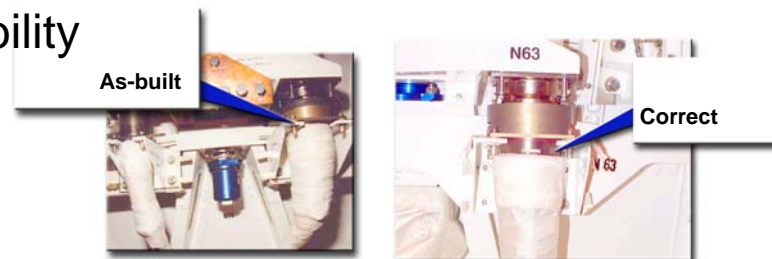
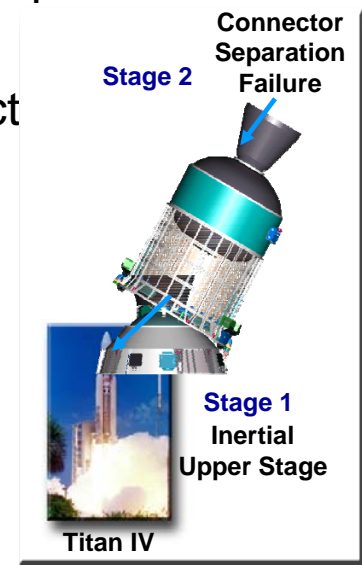
## TITAN IV B-27/INERTIAL UPPER STAGE-21/DSP-19

- IUS stage 1 to IUS stage 2 interface connector failed to separate
  - Inexperienced technicians, inadequate engineering and assembly drawings led to improper application of thermal tape at connector separation plane
  - Inadequate failure modes and effects analysis on connect

- Spacecraft failed to achieve proper orbit greatly reducing operational capability

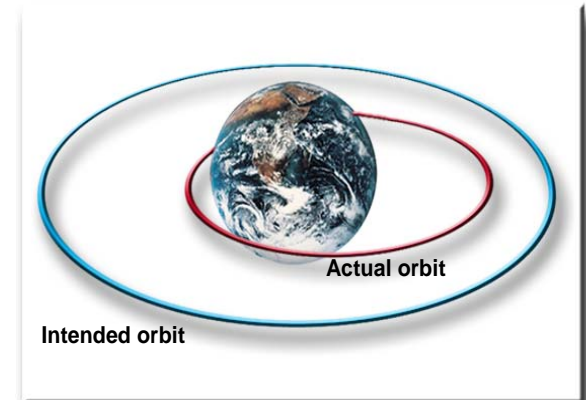
## TITAN IV B-32/CENTAUR TC-14/MILSTAR-3

- Flight software was not used for data validation
- Error in the manual entry of a roll rate filter
  - Correct value -1.992476
  - Value manually entered by technician -0.1992476
- Second Centaur burn failed to achieve correct orbit, resulted in low orbit

- Greatly reduced mission capability

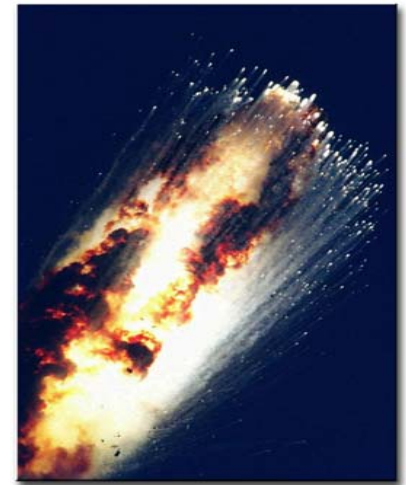
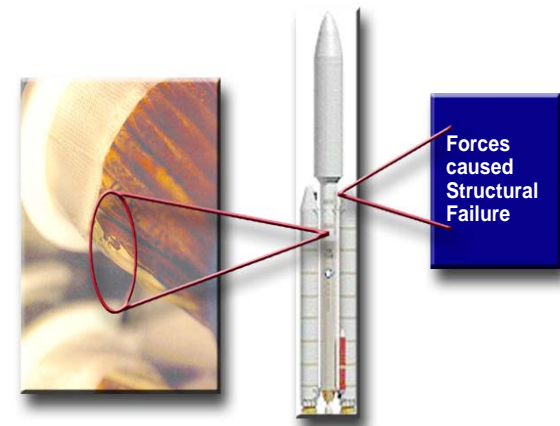
## Titan IV A-20/Centaur/NRO

- 40 seconds after launch shorted wires caused the guidance system to reset and the vehicle to pitch and yaw beyond design loads
- Likely harness damage occurred before launch possibly due to a combination of inadequate design, faulty workmanship, rework or shipping

- Resulted in structural failure and destruction of vehicle

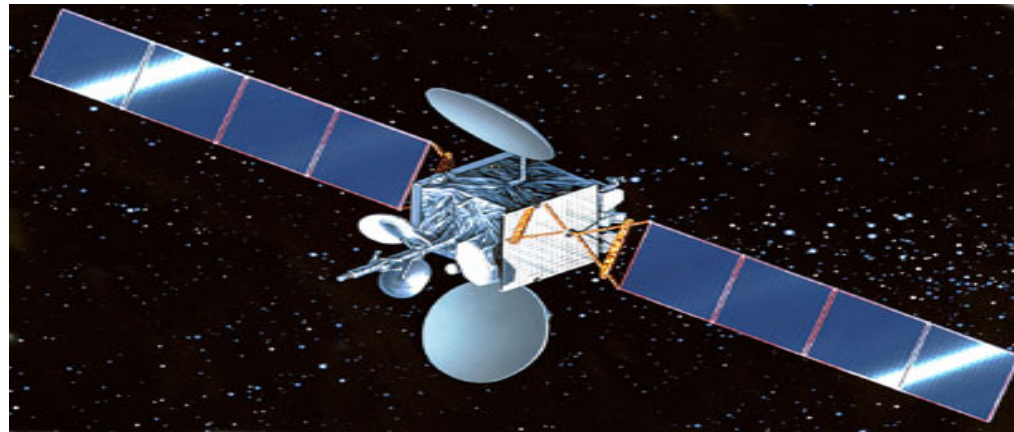
## GALAXY 601

- **Background**
  - August 27, 2000 spacecraft used for cable and broadcast television, national and regional radio transmission, and data relay.
- **Problem**
  - Conformal coating (prevents tin whisker growth) used to cover tin surfaces electronics was improperly applied and thus allowed tin whiskers to bridge a relay terminal causing an electrical short
- **Impact**
  - Satellite lost
  - Cost: \$500M

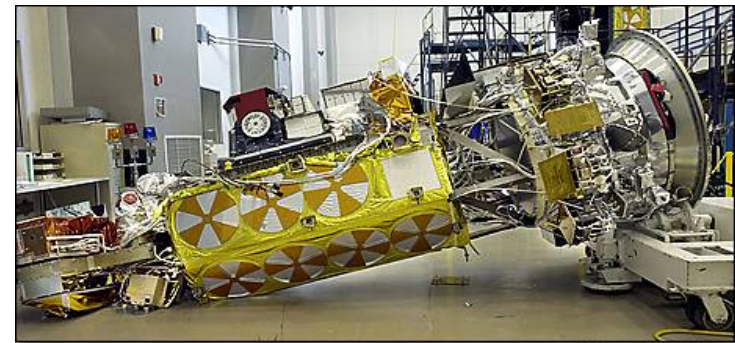
## NOAA-N PRIME WEATHER SATELLITE

- **Background**
  - Television Infrared Observation Satellite (TIROS)
  - TIROS spacecraft is a polar-orbiting meteorological satellite.
- **Problem**
  - Bolts securing the satellite to a turnover cart were removed -Satellite toppled from its platform during tilting operation
  - The causes were identified as a lack of discipline, not following procedures – Responsible Test Engineer (RTE), Production Quality Control (PQC), and Production Assurance (PA) were identified as the offices of primary responsibility.
- **Impact**
  - Complete loss: \$239 Million

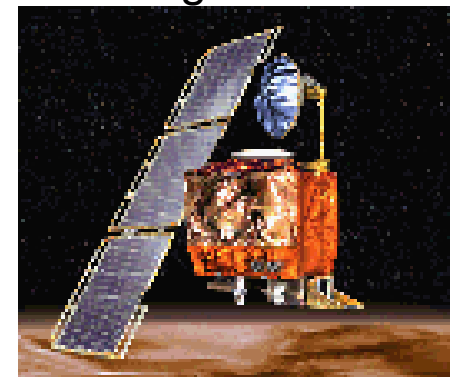
## MARS POLAR LANDER MARS CLIMATE ORBITER

- **Background**
  - The failures of the Mars Climate Orbiter (MCO) and Mars Polar Lander (MPL) in 1999.
- **Problem**
  - The 'root cause' of the MCO failure was the use of data in English units that were thought to be in metric units within a segment of ground-based, navigation-related mission software.
  - The loss of MPL has been traced to premature shutdown of the descent engines, resulting from a vulnerability of the software to transient signals.
  - End-to-End testing, “...inadequate checks and balances that permitted an incomplete systems test and allowed a significant software design flaw to go undetected.”
- **Impact**
  - Loss of both missions (\$327M)

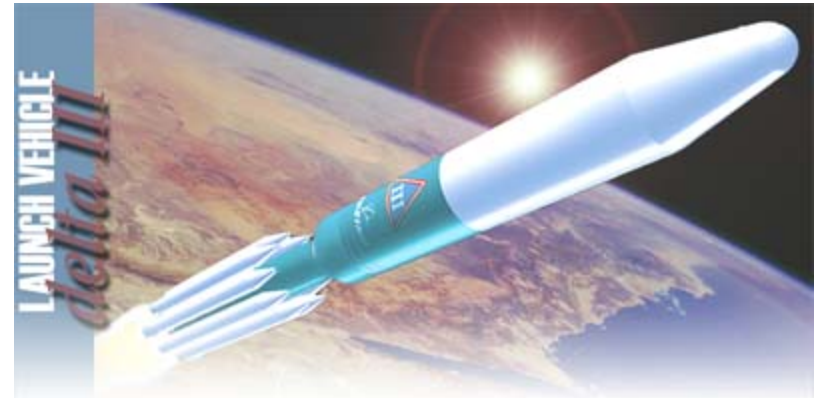
## DELTA III 259/GALAXY-X

- Conscious deviation from normal, proven space design analysis
- The control system tried to correct a slow natural oscillating roll that developed during the first minute of flight. The control system expended all the hydraulic fluid in the thrust vector control system
- Frequency would have been discovered if more thorough standard analysis was performed and filtered

- Lost vehicle and payload
- Significant damage to product line

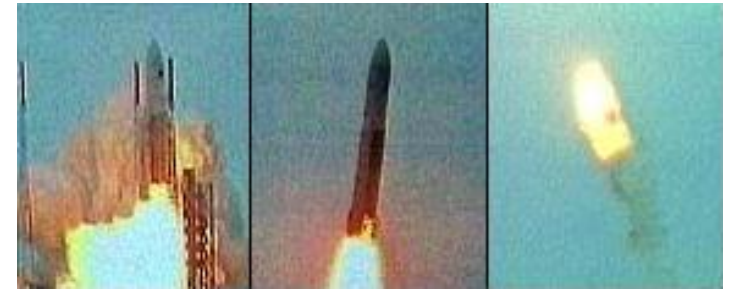
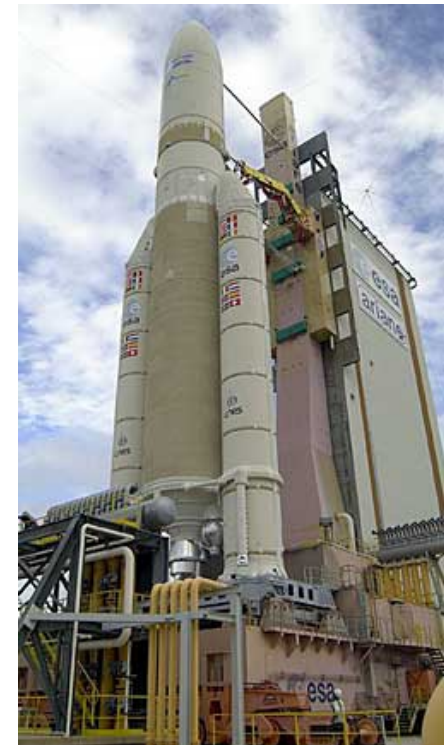
## EUROPEAN SPACE LAUNCHER – ARIANE 5

- Launch failure caused by complete loss of guidance and attitude information 30 seconds after lift-off
- Specification and design errors in the software of the inertial reference system.
- Reuse of Ariane 4 software and values.

- The destroyed rocket and its cargo were valued at \$500 million.
- Loss of future launch contracts

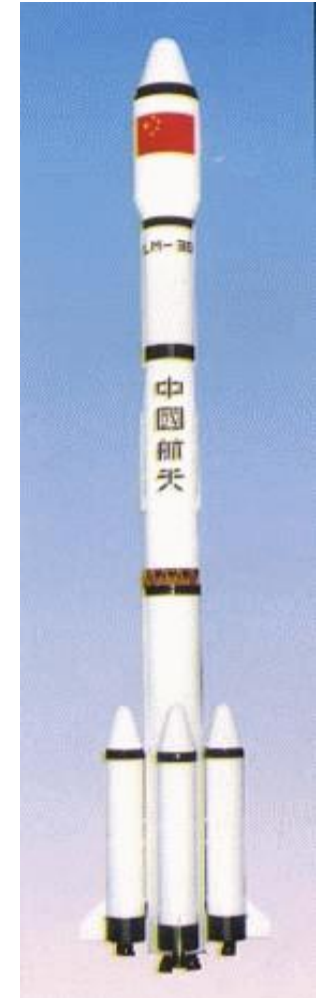
## CHINESE SPACE LAUNCH FAILURE

- **Background**
  - CZ-3B was China's most powerful launch vehicle.
  - It had a payload of 5,000kg, and four liquid-fuel boosters strapped onto the core stage.
  - 1996-1998
- **Problem**
  - The CZ-3B began to veer off course two seconds after liftoff.
  - A gold-aluminum solder joint in one of the gyro servo loops failed.
  - Malfunction of the inertial guidance system
  - The vehicle and its payload hit the ground and exploded
- **Impact**
  - Crashed and devastated a village causing death and injuries
  - Cost: \$125 million dollars

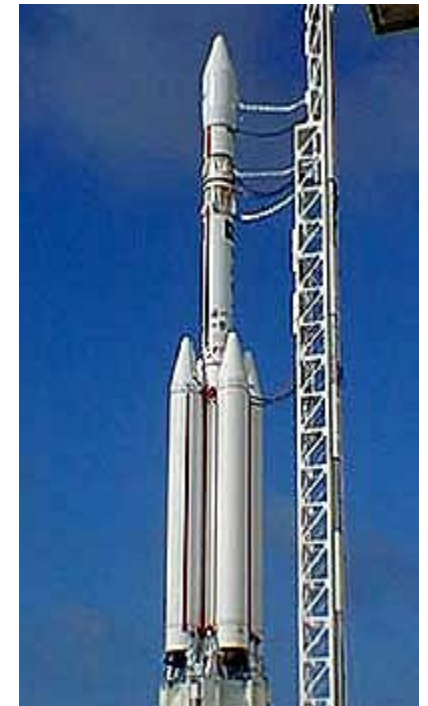
## BRAZIL SPACE PROGRAM'S SATELLITE LAUNCH VEHICLE (VLS)

- **Background**
  - Brazil attempting to develop a satellite launch vehicle
  - Four-stage rocket using solid propellants
  - Much of the technology for the VLS was derived from early Brazilian Sonda-class sounding rockets.
- **Problem**
  - Program plagued by quality problems and successive launch failures (1997-2004):
    - First Launch - Rocket off course and destroyed.
    - Second Launch -destroyed in-flight when the rocket again veered off course.
    - Third Launch - Explosion on launch pad during launch preparation
- **Impact**
  - Third Launch - 21 Lives lost
  - Processing facilities and launch pad destroyed

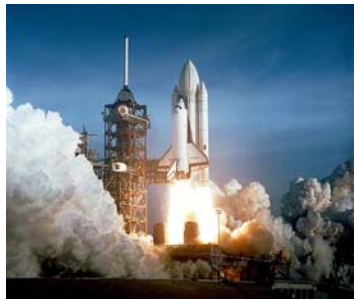
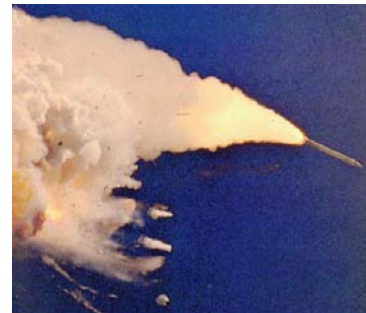
## Space Shuttle

- **Background**
  - Shuttles Developed in early 1970s
  - First flight April 1981
- **Problem**
  - Challenger loss caused by a failure in the joint between the two lower segments of the right Solid Rocket Motor.
  - Columbia loss caused by a breach in the Thermal Protection System on the leading edge of the left wing.
  - Combination of design and manufacturing flaws coupled with management failures lead to both accidents.
- **Impact**
  - Destruction of Challenger and Columbia and loss of life

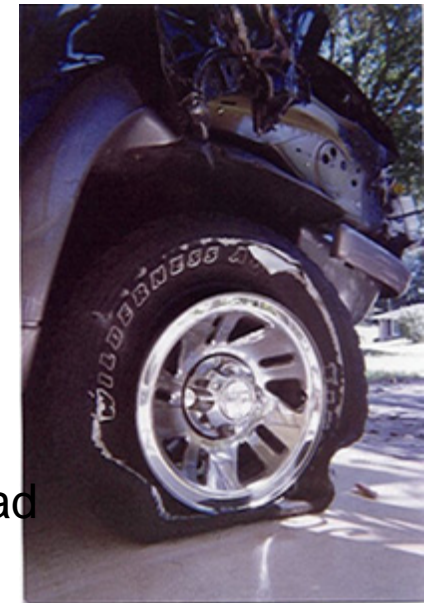
## FIRESTONE TIRE RECALL

- **Background**
  - Wilderness All Terrain tires on Ford Explores manufactured at Decatur Illinois plant
  - Recalled in 2000 for tread separation
- **Problem**
  - Manufacturing equipment malfunctions
    - Lead to air void between tread and steel belt
    - Lower cohesion levels between belt and tread
  - Design defects
    - Design creates excessive stress between belt and tread
  - Inadequate testing
- **Impact**
  - Loss of life

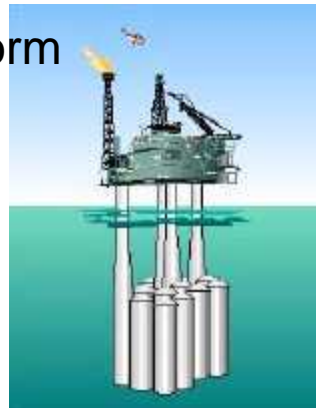
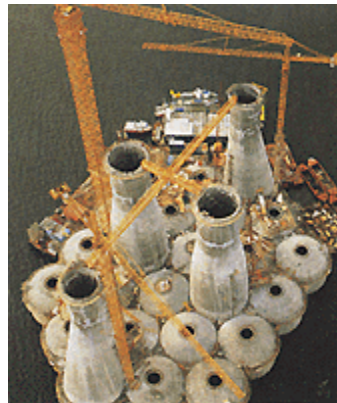
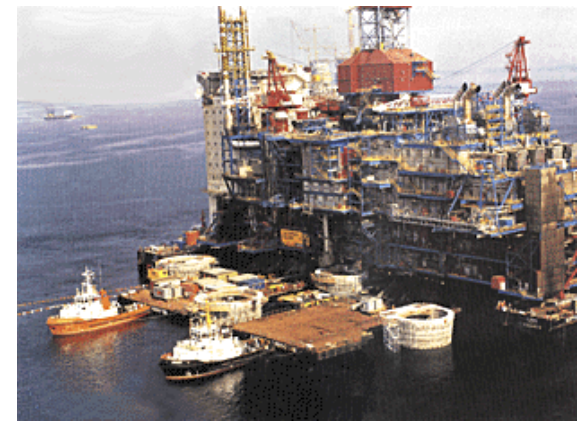
## SLEIPNER NORTH SEA OIL PLATFORM

- **Background**
  - Statoil (Norwegian Oil Co.), August 1991
  - Platform supported by four elongated concrete cells, one of which sank during a standard blasting operation
- **Problem**
  - Inaccurate finite element analysis performed on concrete support structure.
  - Shear stresses underestimated by 47%
  - Concrete structure failed.
- **Impact**
  - \$1B
  - Loss of platform

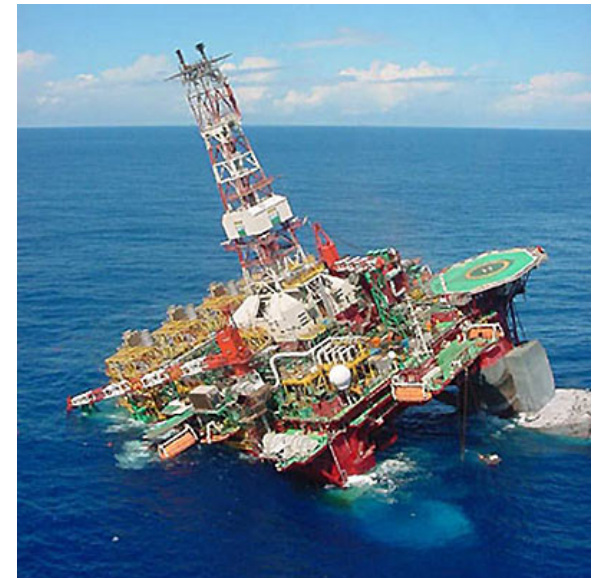
## BRAZILIAN OIL COMPANY PETROBAS OIL PLATFORM

- **Background**
  - Oil platform inaugurated in 2000
  - Located in Campos Basin, 80 miles off the coast of Rio de Janeiro
  - Supplies 5% of Brazil's total oil output
- **Problem**
  - Ignored daily bulletin advisories about valve and pump failures
    - Pressurization in platform vent system
    - Build up of Hydrocarbons
    - Rupture of tanks resulting in fire
  - Damage to flotation tower due to rupture of tanks
    - Resulting in collapse of platform
- **Impact**
  - Loss of 10 lives
  - \$500M structural loss
  - \$41.5M increase in insurance premiums
