## Engineering Failure Analysis - A Review

- Mr. Abraham Pannikottu  
Operations Manager

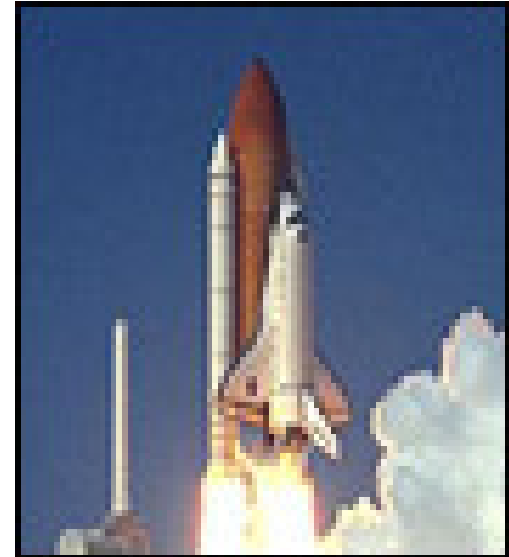
## SPACE SHUTTLE PROGRAM AUTOMATED CHECK-OUT & LAUNCH CONTROL SYSTEM

- **Background**
  - Primary objective: to reduce cost, increase performance and increase efficiency over legacy system
  - CLCS was intended to provide ground support equipment control
  - Began 1997 and canceled 2002
- **Problem**
  - Lack of disciplined software development resulted in cost growth, schedule slippage and reduced functionality
- **Impact**
  - Cost estimate increase from \$207M to \$533M
  - Cancellation of program after \$300M spent

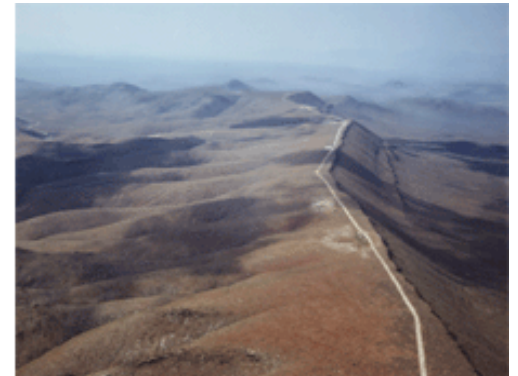
## NUCLEAR WASTE REPOSITORY AT YUCCA MOUNTAIN

- **Background**
  - First long-term geologic repository for spent nuclear fuel and high-level radioactive waste.
  - NRC requires nuclear facilities to develop a quality assurance program
- **Problem**
  - DOE auditors identified significant problems with data sources, validation of scientific models, and software development.
    - Data sets could not be traced back to their original sources
    - No standardized process to develop scientific models needed to simulate geological events
    - No process for ensuring that software being developed to support the models would work
- **Impact**
  - Continuing delay of repository licensing, operation and stockpiling of spent fuel
